Customer
1 Main Street
Anytown, NY 10950

Proposal

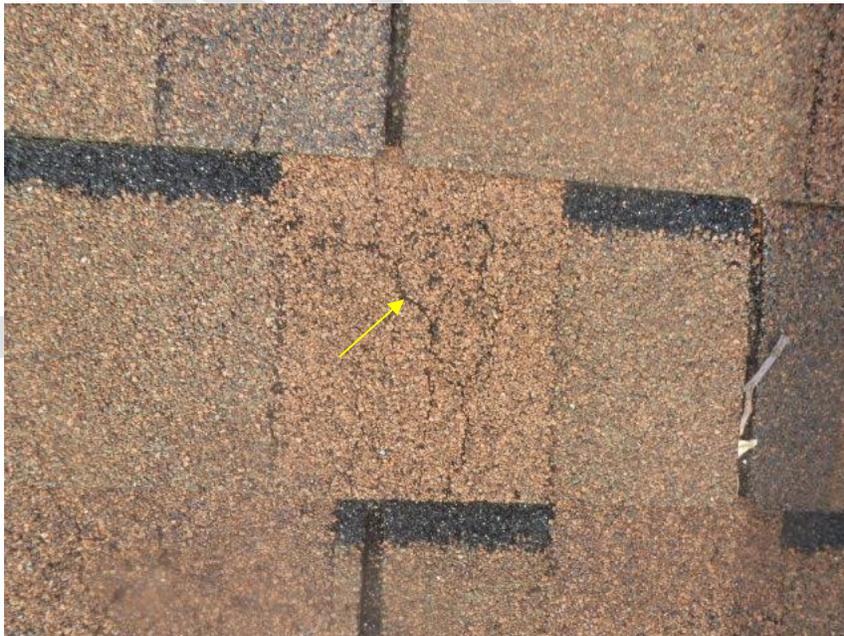
Shingles are a Certaineed Horizon “Shangle”. Note the standard cracking failure in the overlaid appliqué emblematic of a known product problem.

6. Install new GAF 50-Year Timberline HD architectural shingles over entire house. New Timberline High Definition shingles have a 110 mile per hour limited wind warranty and a UL Class A fire rating. New shingles to be installed as per manufacturer's specifications with respect to fastener placement and pattern layout. Color choice by customer. Color to be (_____).

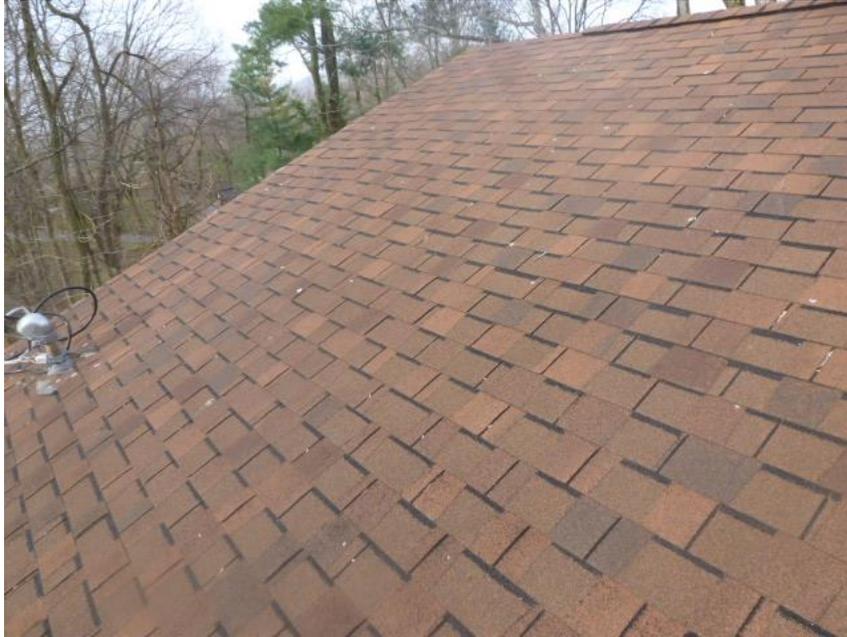
Roof condition is fair

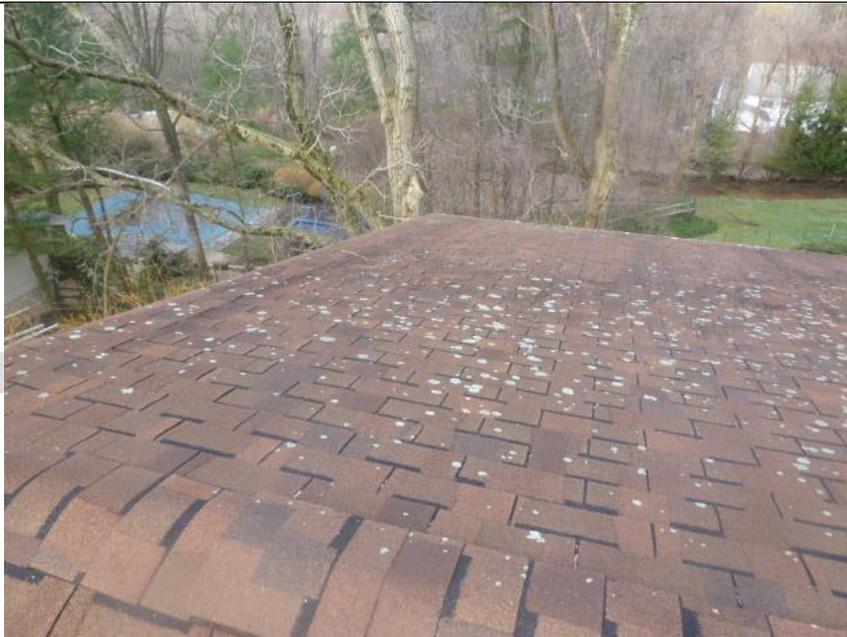
Rear slope with moss growth

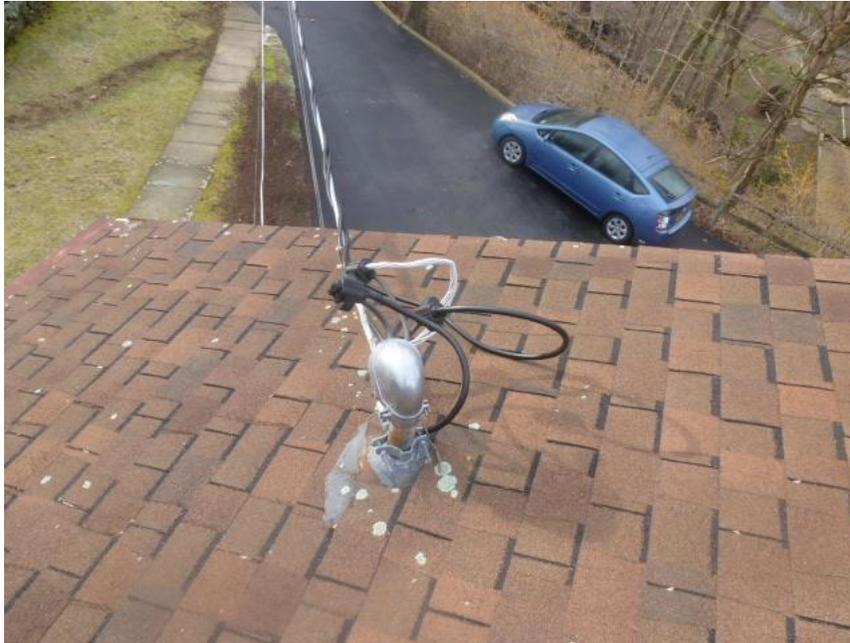
The electrical mast head is very close to the roof. Normally a comfortable distance exists between the energized wires and the roof level.

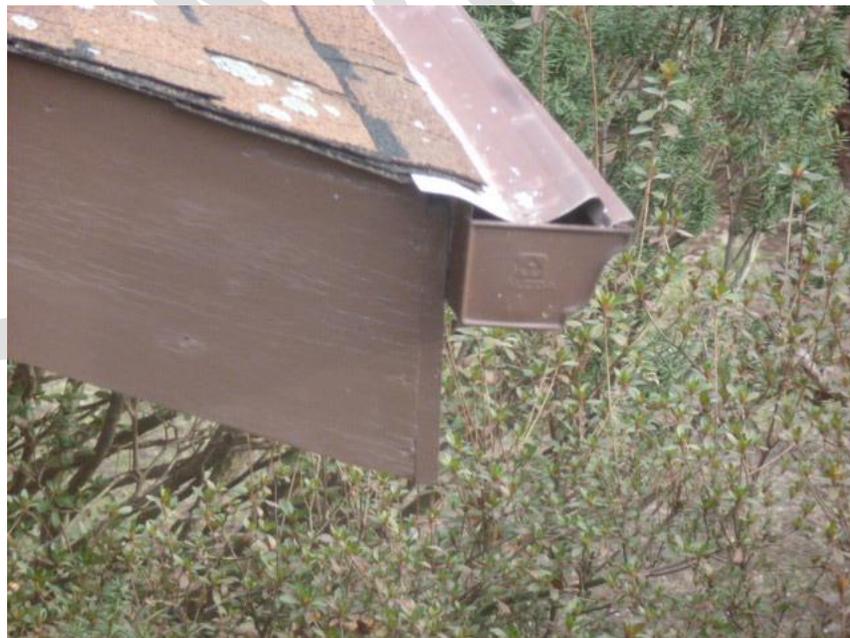
An ill-fitting gutter cover is in place. It is improperly installed and must be corrected or replaced with a suitable cover

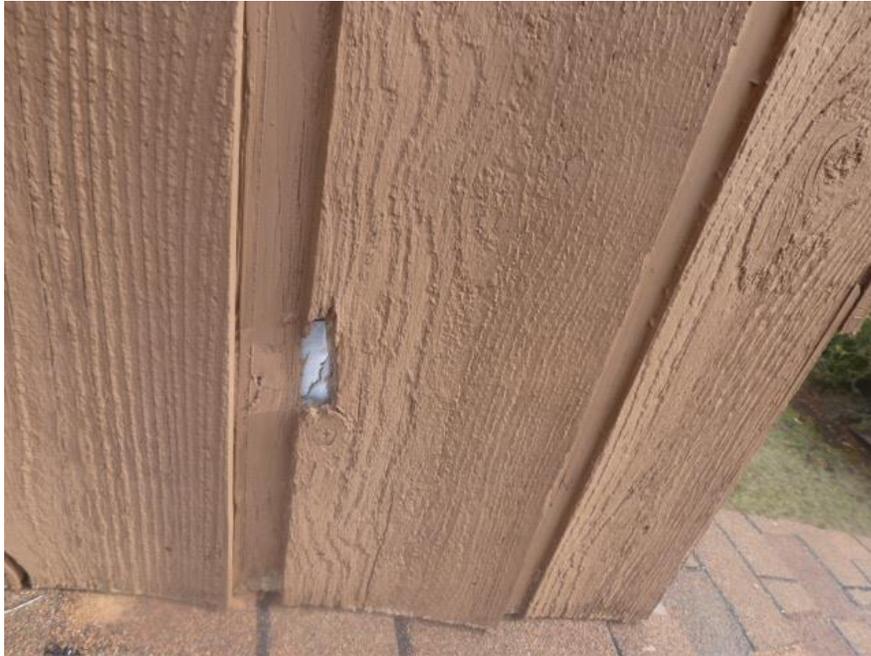
The channel cedar siding on the walls with a southern exposure are in need of replacement.

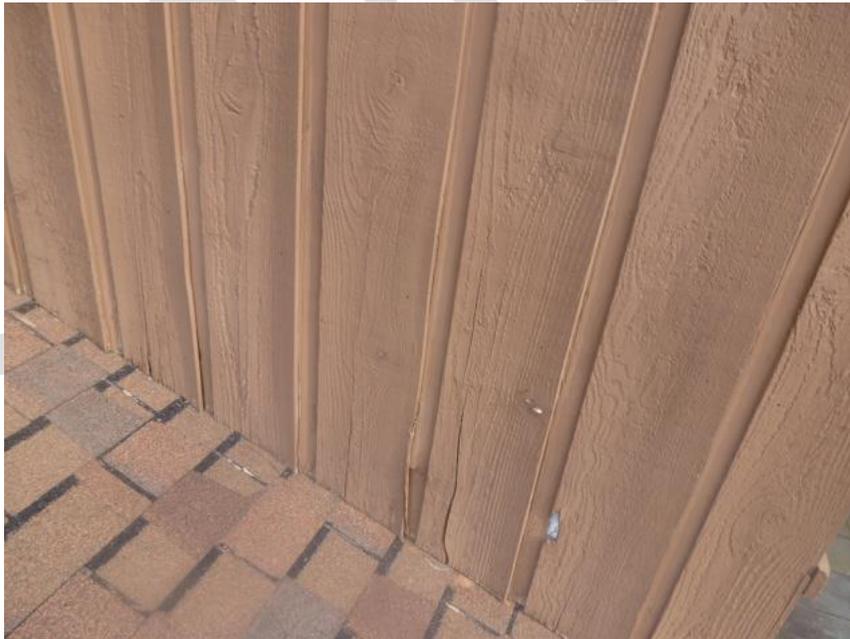
The channel cedar siding on the walls with a southern exposure are in need of replacement.

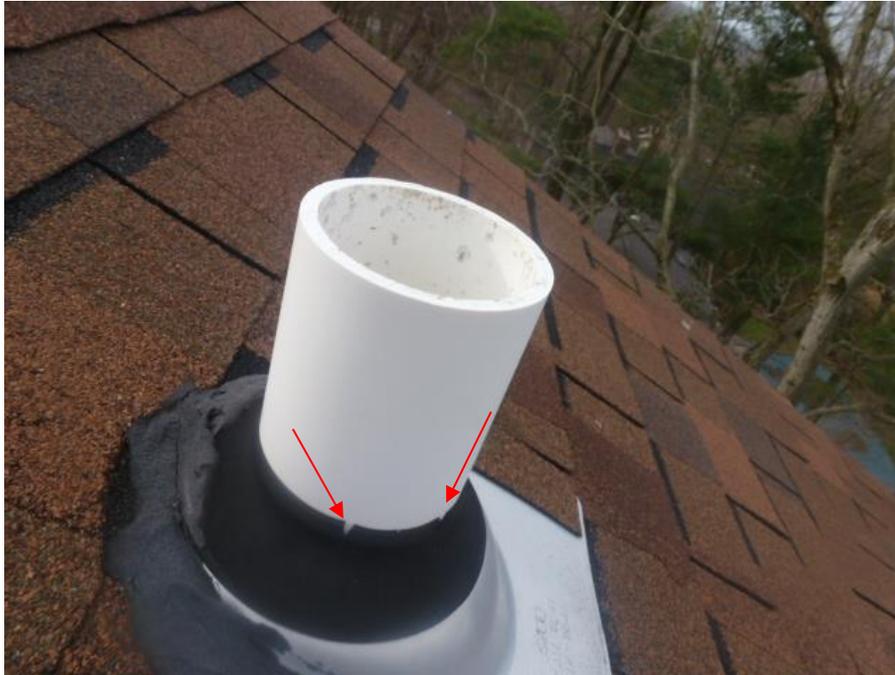
Rubber seal at vent pipe is beginning to fail

7. Install new aluminum flanged vent pipe flashings at all vent pipes.
8. Install new Cobra snow country ridge vent at all ridges that can be properly ventilated. Proper ventilation requires that your home presently has existing vents in the soffits. In conjunction with this work we will close off or cover any conflicting gable vents with

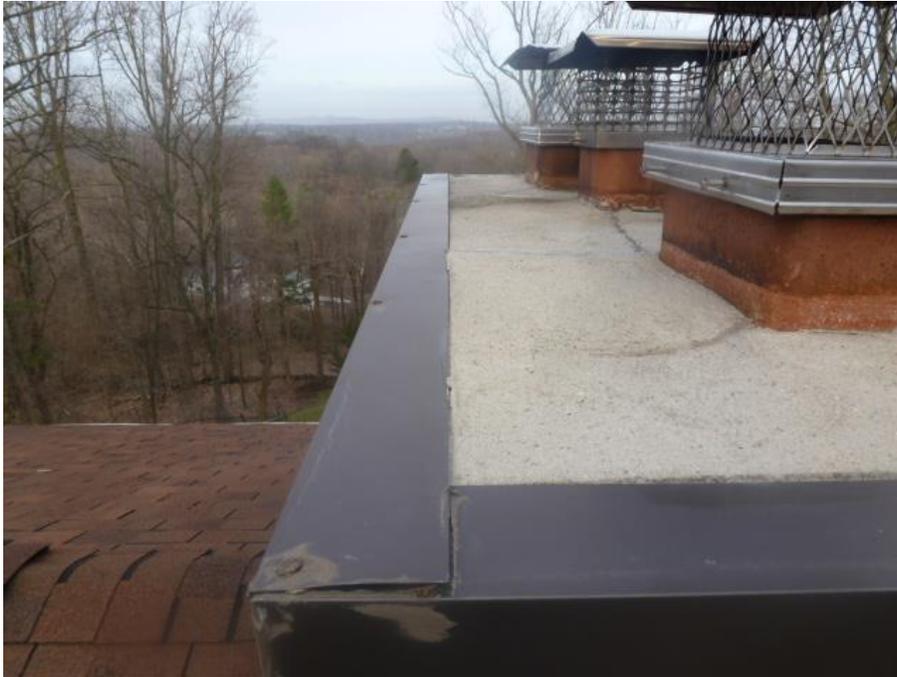
Metal edge on top of chimney was never sealed to masonry.

13. Remove channel siding in a 9" width parallel to roof by cutting and removing lower ends of vertical boards near roof. Extend ice shield fully around chimney adhered directly to plywood sheathing. Install a new copper chimney flashing including new apron, step, and back pan flashing with soldered corner. Install copper Z molding and new pine trim primed brown. No finish painting is included in our price. We can make wood available for priming and painting by others prior to job start.

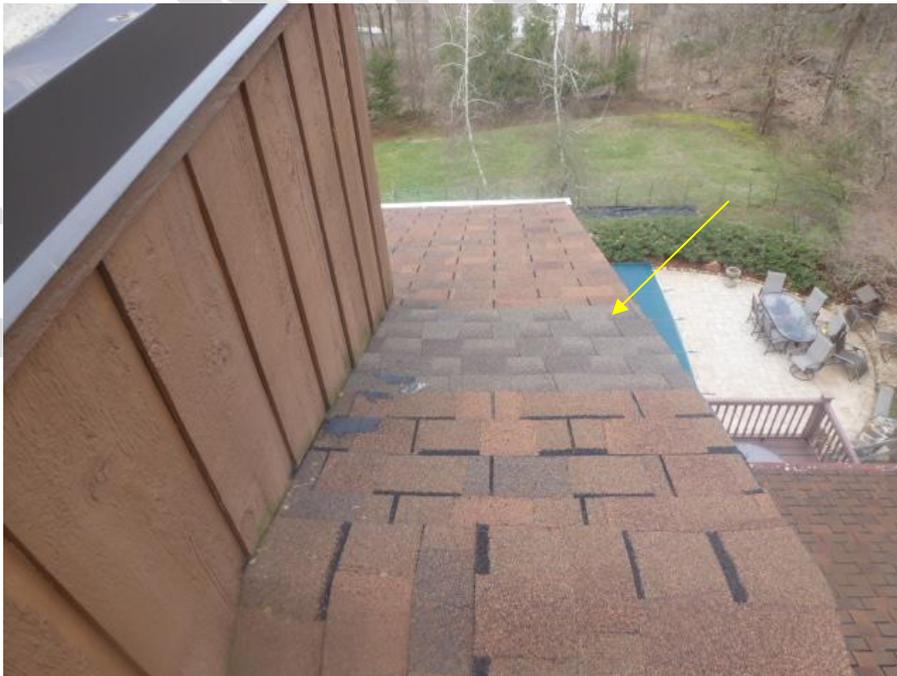
Previous wind damage repair to roof by handyman.

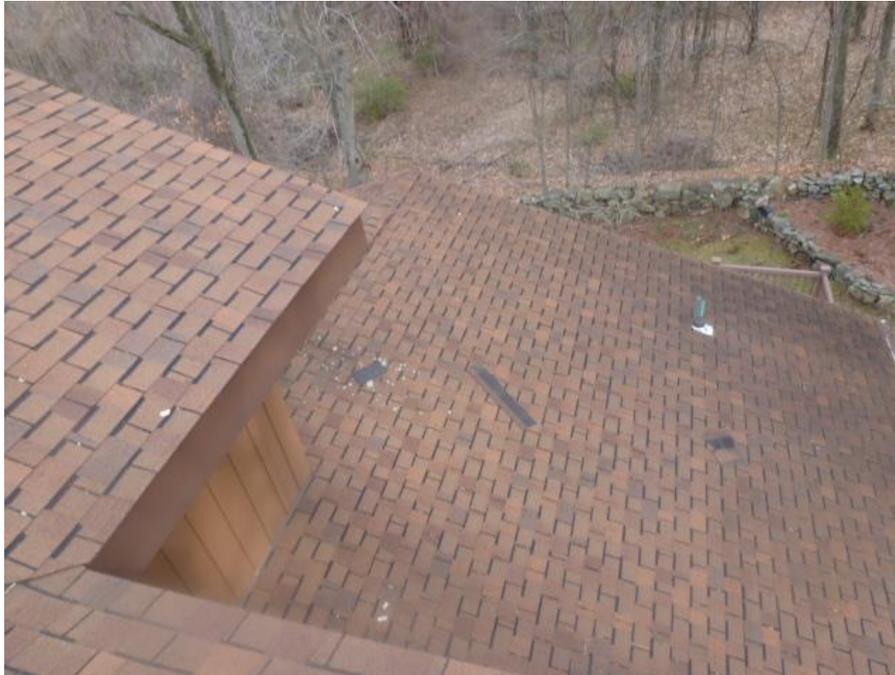
Lower roof – right front - with shingle from previous wind damage.

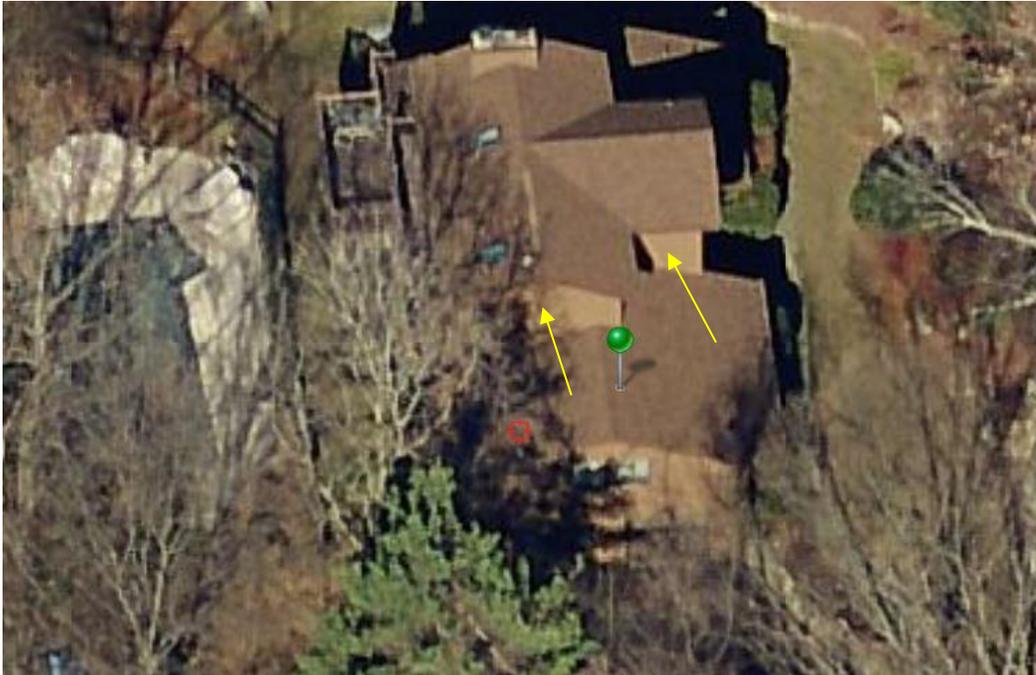
Siding is to be removed and replaced on these two walls if the option to the contract is chosen.
